## Town of Redcliff

### Inflow-Infiltration Study Wastewater Master Plan Update

April 2015

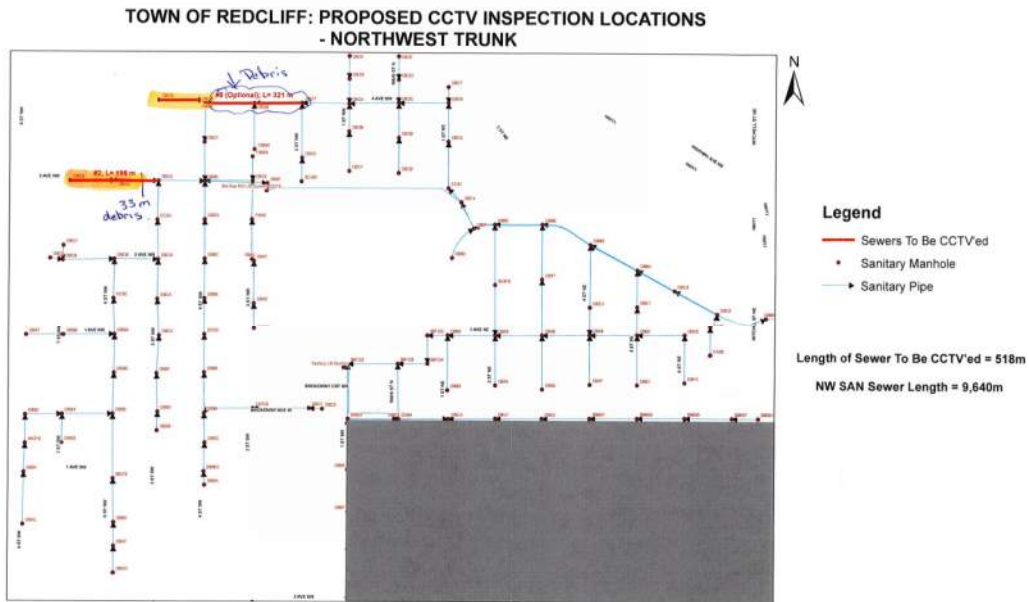
Figure 6.9 – NW CCTV Inspections

SFE Global was retained for the CCTV pipe inspection. The CCTV inspection report is attached in Appendix C, with snapshots showing the locations inspected below in Figure 6.9 and 6.10 (note that full size versions of these are included in Appendix C, in the Appendix II section of the SFE report.

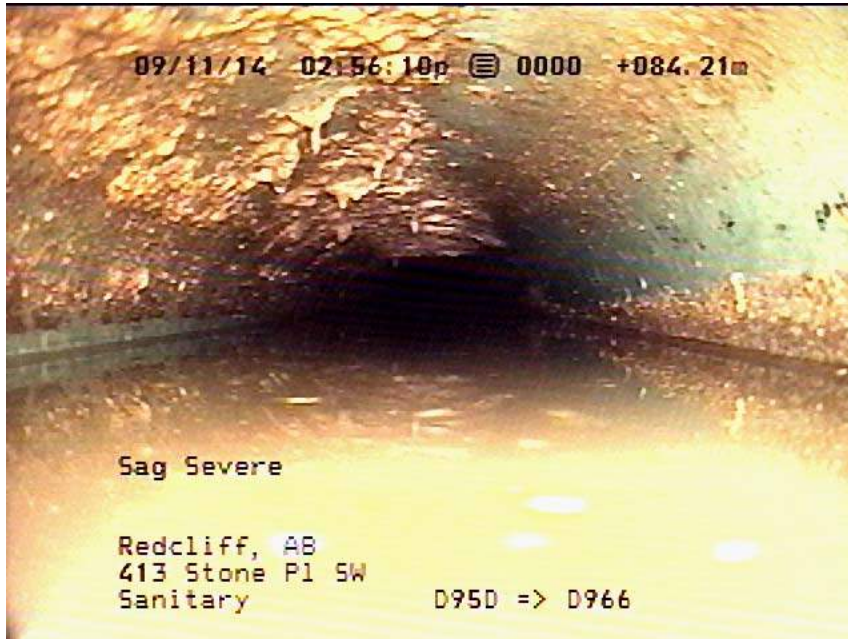
Photo : 7  
Distance : 84.21 m  
Video : 00:00:00  
DC :  
Code : SS  
Sag Severe

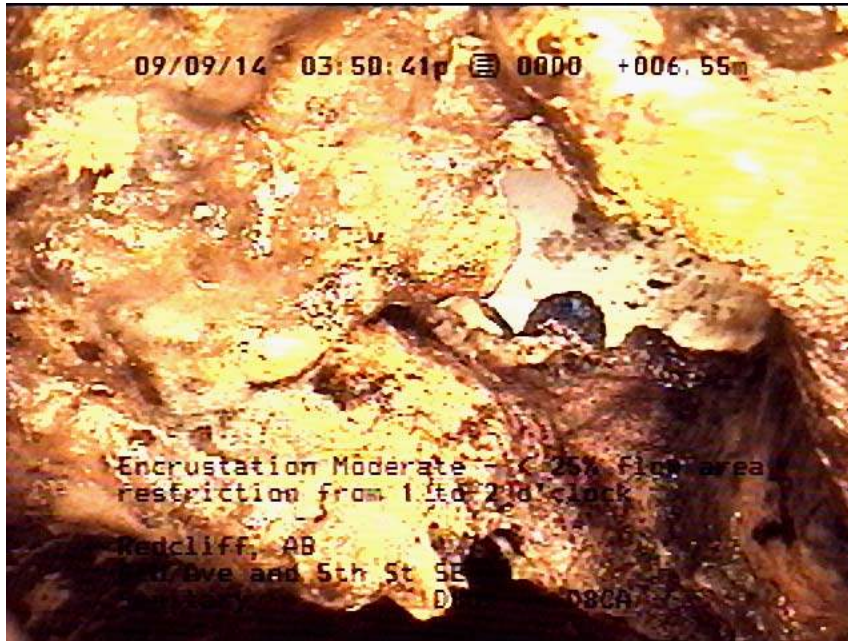
Photo : 1  
Distance : 6.55 m  
Video : 00:00:00  
DC :  
Code : EM  
Encrustation Moderate -  
< 25% flow area restriction  
from 1 to 2 o'clock

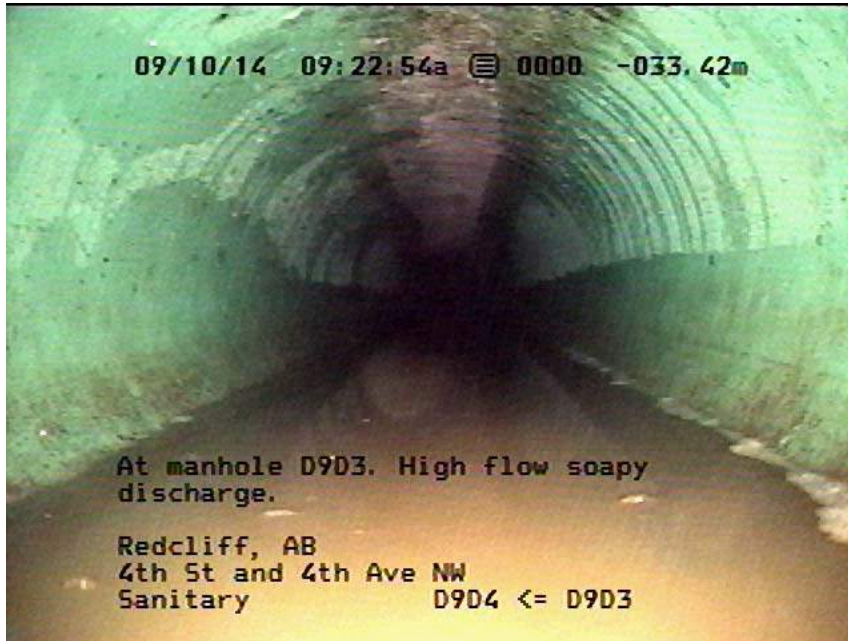
Photo : 4  
Distance : 1.00 m  
Video : 00:00:00  
DC :  
Code : II  
At manhole D9D3. High flow soapy discharge.

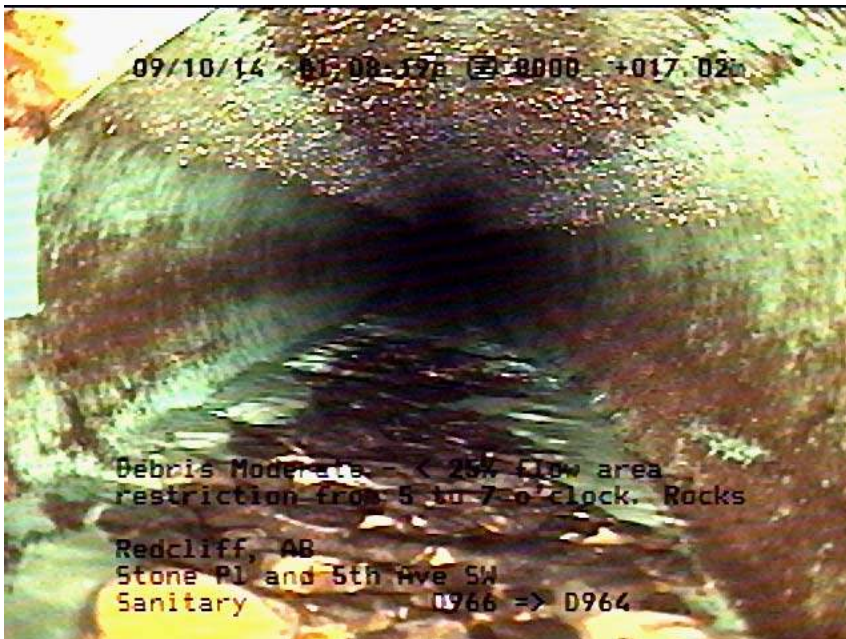
**Photo** : 2  
**Distance** : 17.02 m  
**Video** : 00:00:00  
**DC** :  
**Code** : BM  
Debris Moderate - < 25%  
flow area restriction from 5  
to 7 o'clock. Rocks

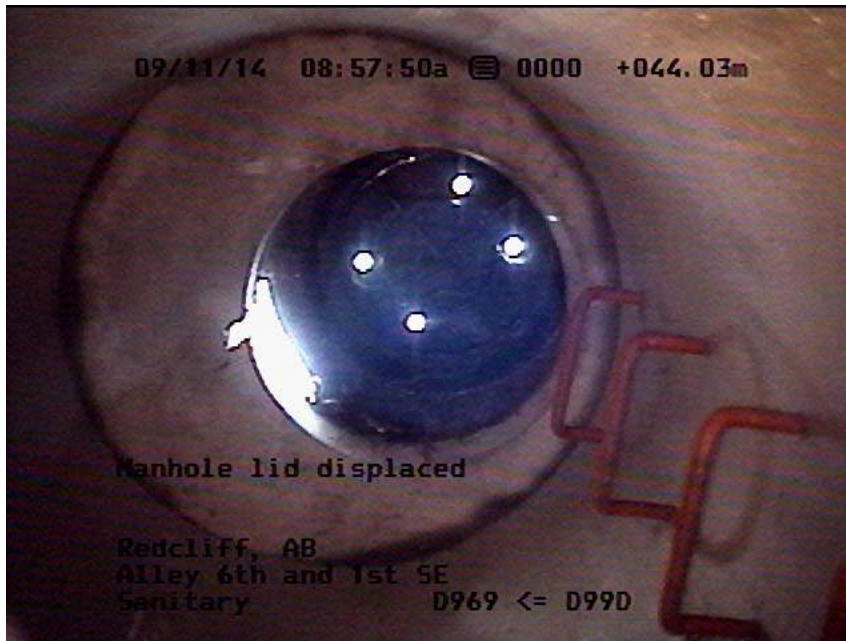
Photo : 1  
Distance : 44.03 m  
Video : 00:00:00  
DC :  
Code : II  
Manhole lid displaced

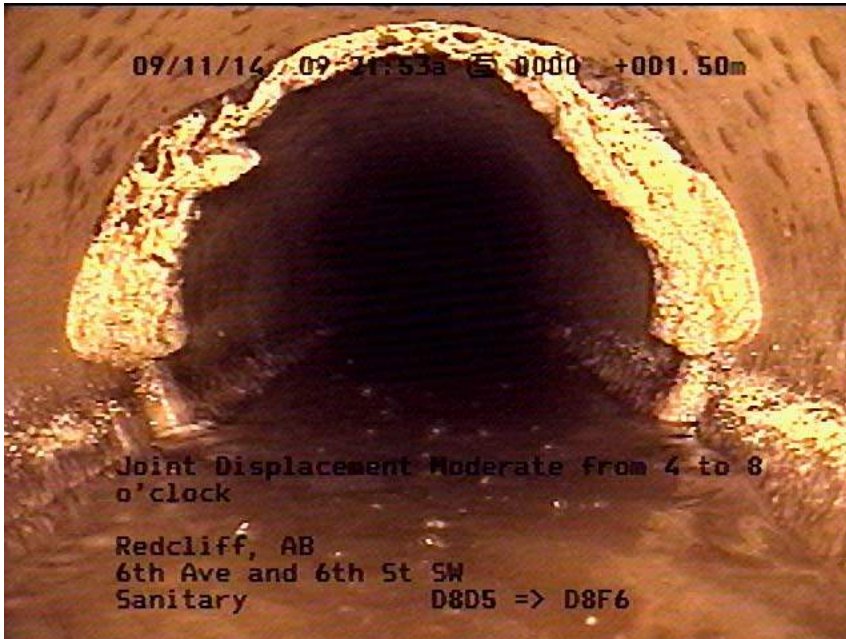
Photo : 1  
Distance : 1.50 m  
Video : 00:00:00  
DC :  
Code : JM  
Joint Displacement  
Moderate from 4 to 8  
o'clock

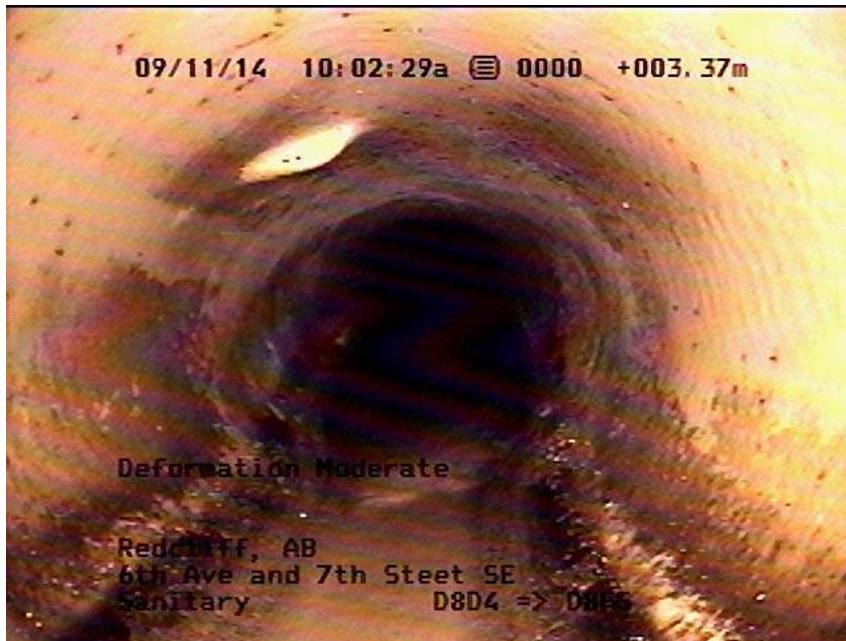
Photo : 1  
Distance : 3.37 m  
Video : 00:00:00  
DC :  
Code : DM  
Deformation Moderate

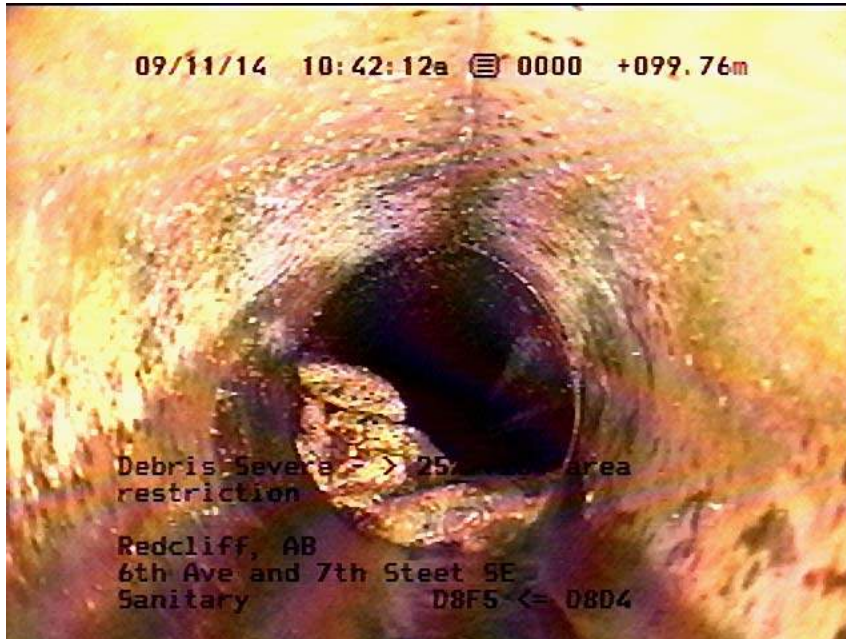
Photo : 5  
Distance : 99.76 m  
Video : 00:00:00  
DC :  
Code : BS  
Debris Severe - > 25%  
flow area restriction

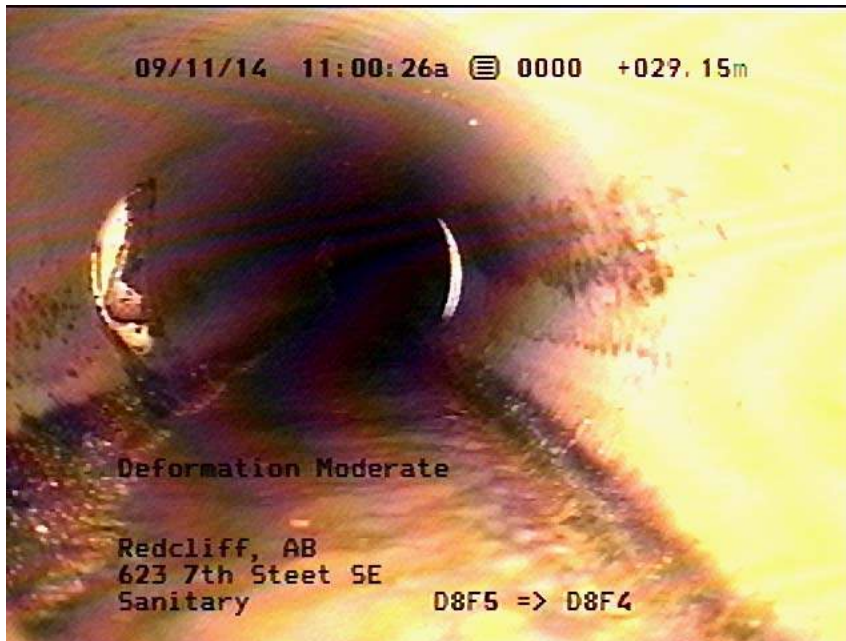
**Photo** : 1  
**Distance** : 29.15 m  
**Video** : 00:00:00  
**DC** :  
**Code** : DM  
Deformation Moderate

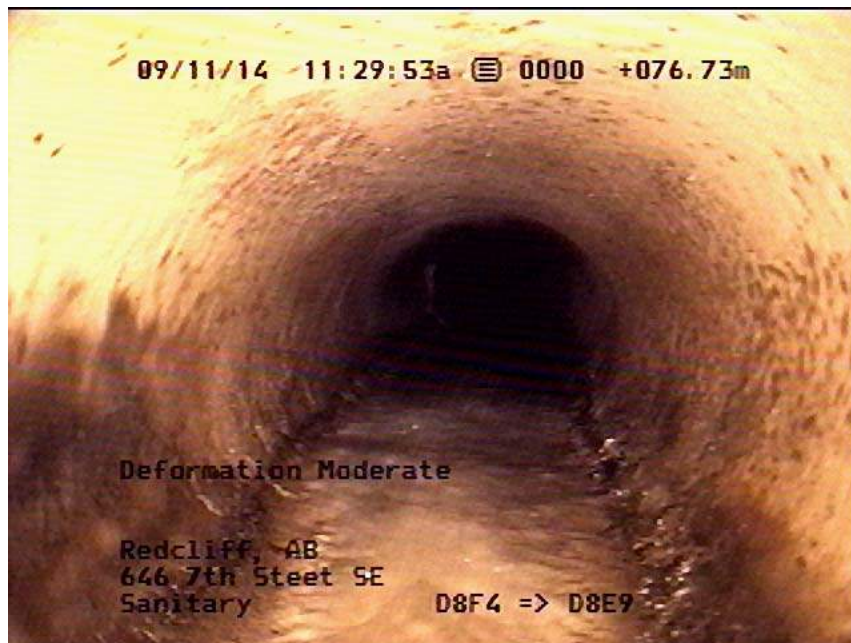
Photo : 1  
Distance : 76.73 m  
Video : 00:00:00  
DC :  
Code : DM  
Deformation Moderate

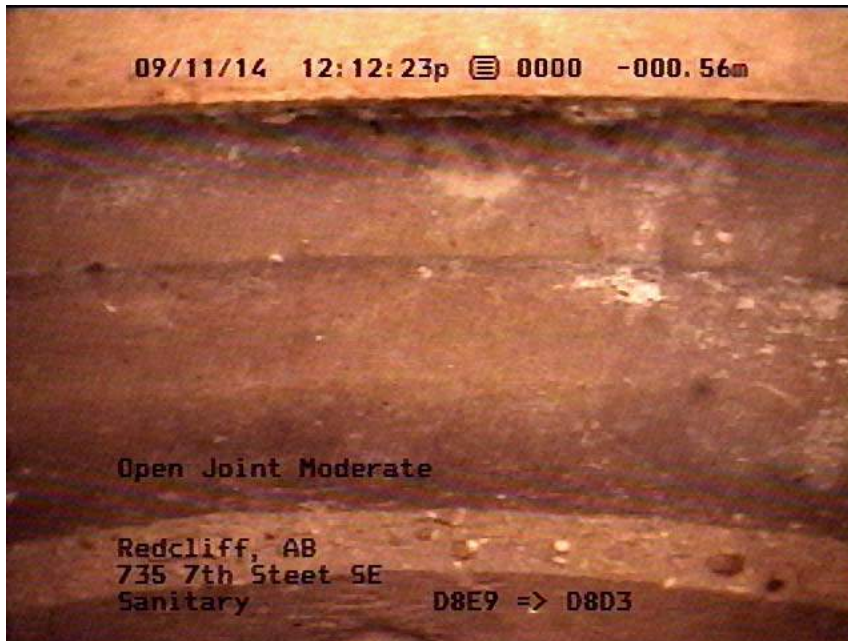
**Photo** : 1  
**Distance** : -0.56 m  
**Video** : 00:00:00  
**DC** :  
**Code** : OM  
Open Joint Moderate

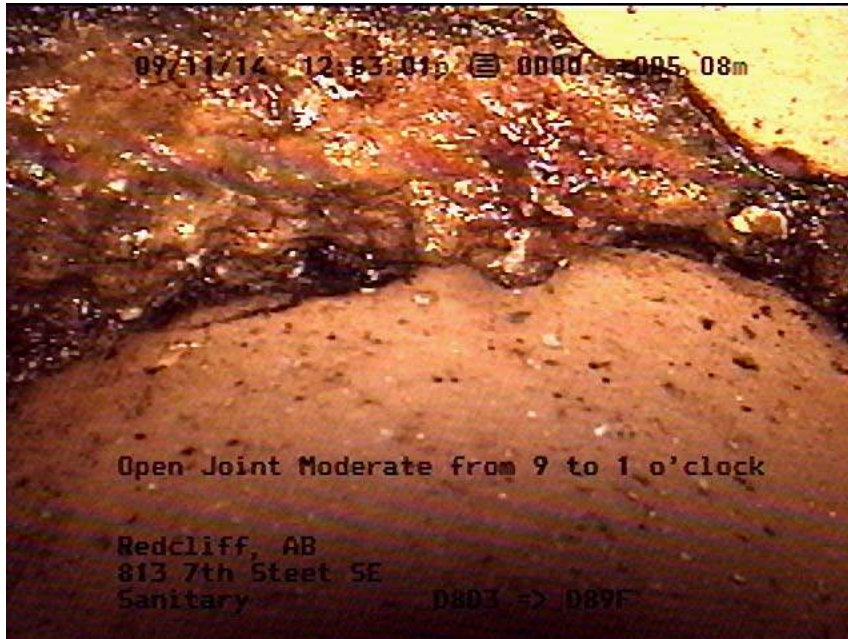
Photo : 1  
Distance : 5.08 m  
Video : 00:00:00  
DC :  
Code : OM  
Open Joint Moderate from  
9 to 1 o'clock

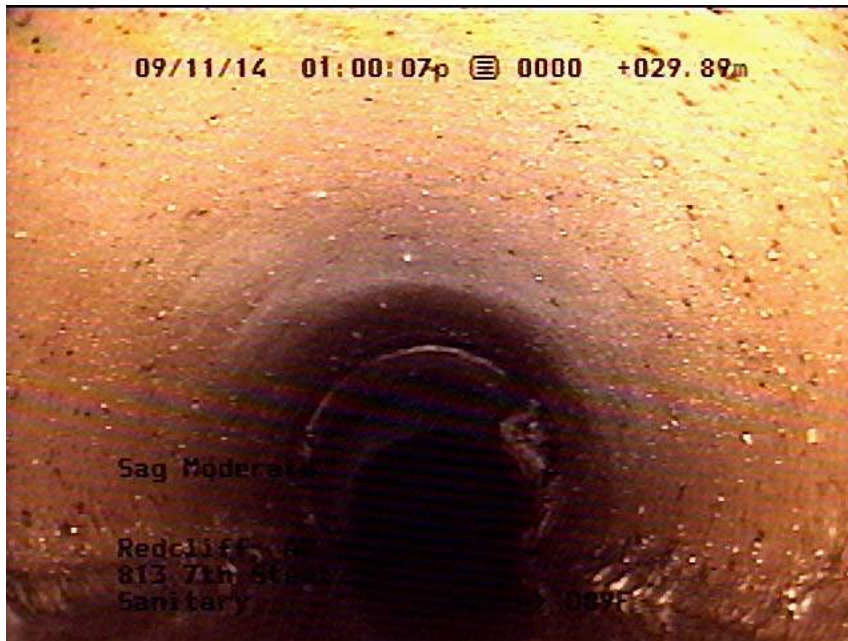
Photo : 3  
Distance : 29.89 m  
Video : 00:00:00  
DC :  
Code : SM  
Sag Moderate

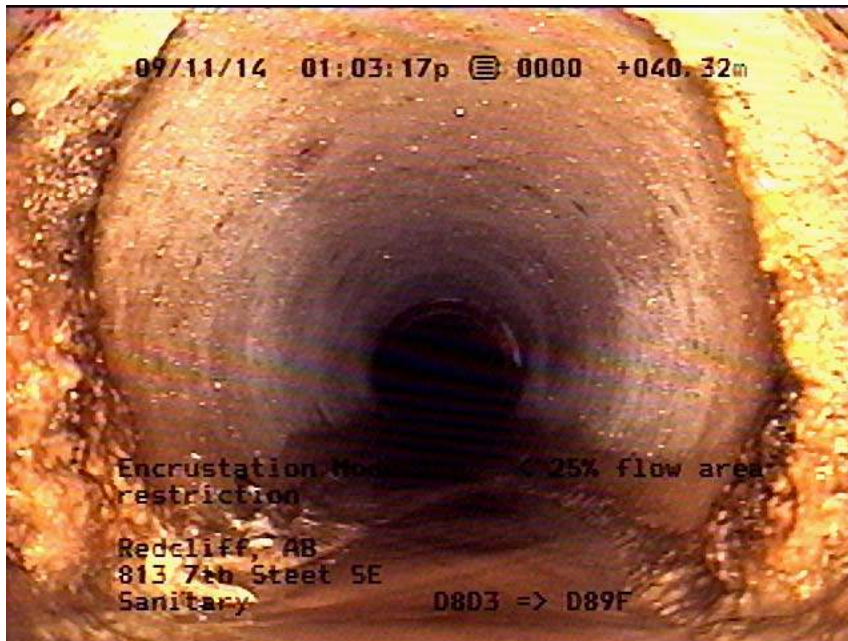
Photo : 5  
Distance : 40.32 m  
Video : 00:00:00  
DC :  
Code : EM  
Encrustation Moderate -  
< 25% flow area restriction

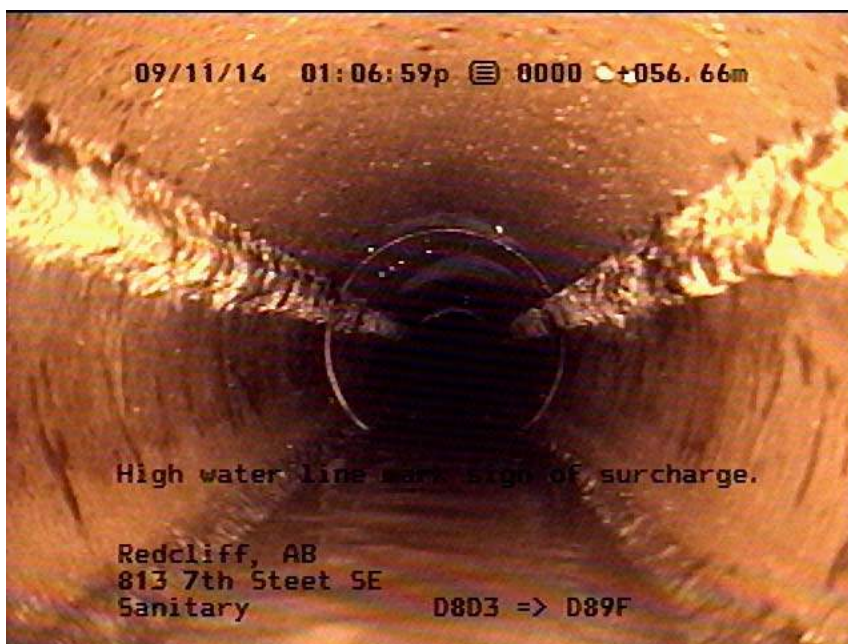
Photo : 6  
Distance : 56.66 m  
Video : 00:00:00  
DC :  
Code : II  
High water line mark sign  
of surcharge.

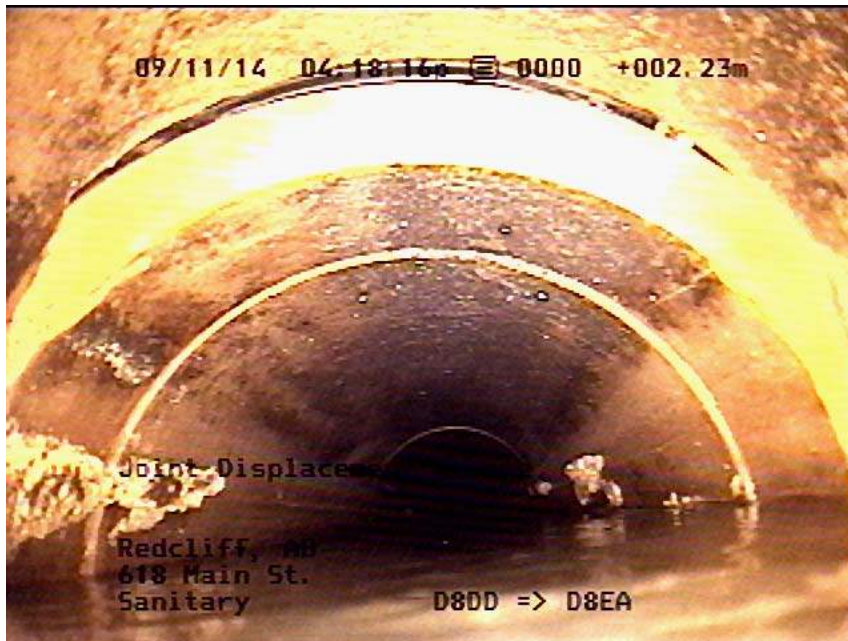
**Photo** : 1  
**Distance** : 2.23 m  
**Video** : 00:00:00  
**DC** :  
**Code** : JS  
Joint Displacement  
Revere

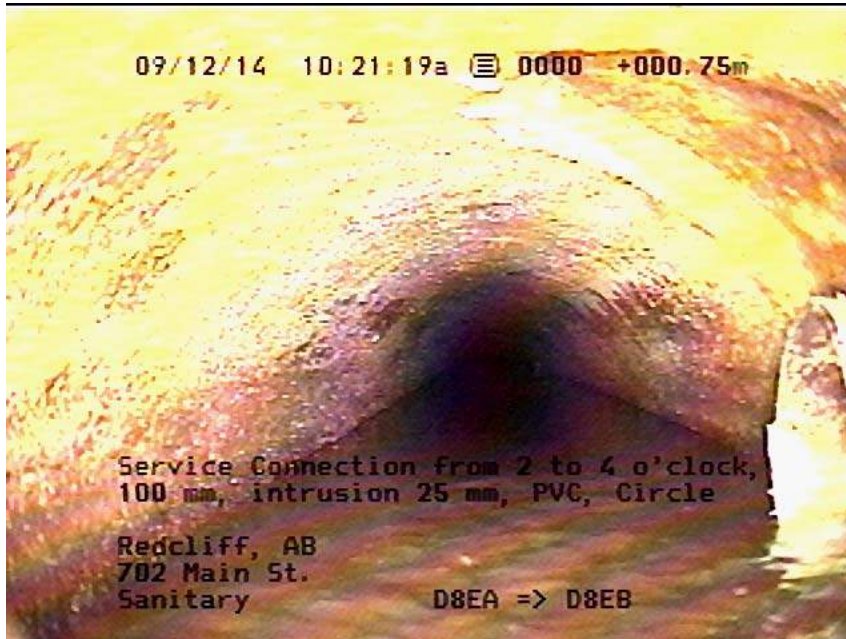
**Photo** : 1  
**Distance** : 0.75 m  
**Video** : 00:00:00  
**DC** :  
**Code** : CN  
Service Connection from  
2 to 4 o'clock, 100 mm,  
intrusion 25 mm, PVC,  
Circle

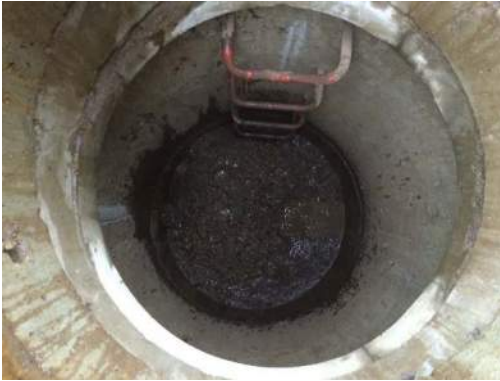
Manhole was plugged with gravel all along the bottom.  
Service condition looked fine.

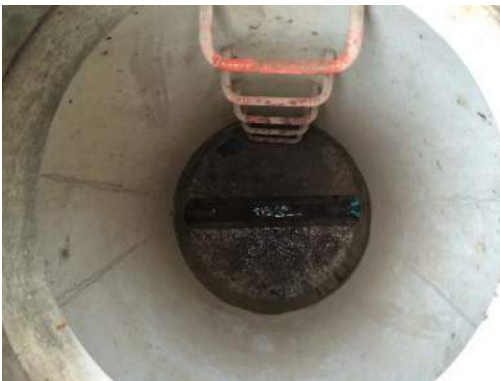
**Manhole: D9CA**

Manhole lower barrel joint leaking.  
Service condition looked fine.

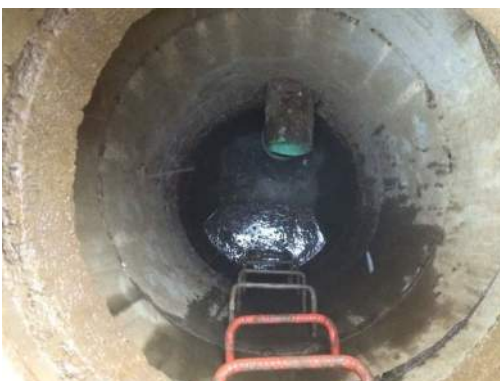
**Manhole: D9CC**

Lots of flow from South. Manhole condition is OK.

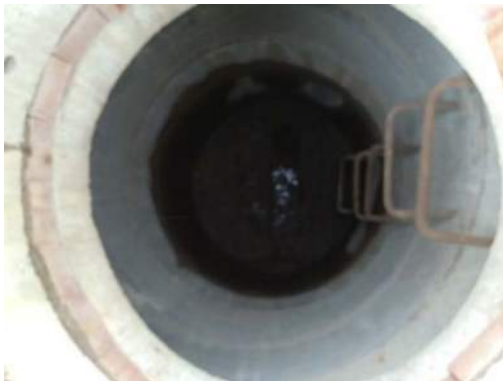
**Manhole: D95D**

Unable to enter manhole has debris.  
Service condition looked fine.
