## Town of Redcliff

### Inflow-Infiltration Study Wastewater Master Plan Update

April 2015

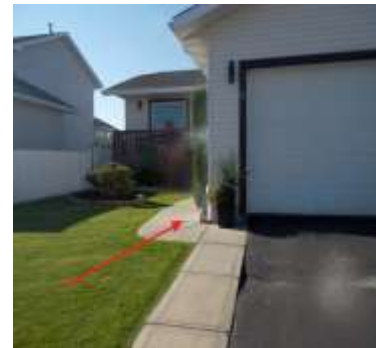
1a - 26AUG14

**Observations:** Downspout from eaves connected to sanitary service.

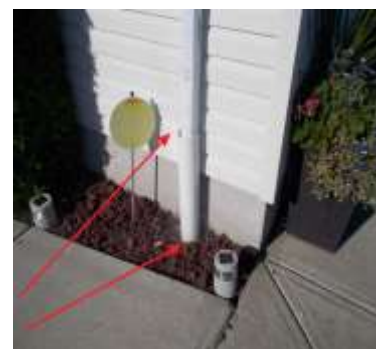
1 - 26AUG14

**Observations:** Downspout from eaves connected to sanitary service.

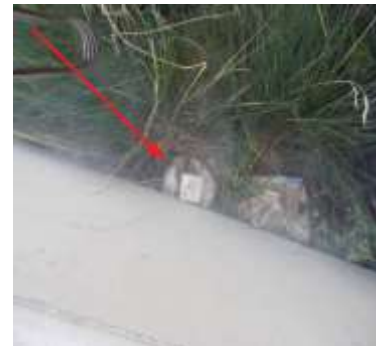
2 - 26AUG14

**Observations:** Cleanout Cap Defective. Next to concrete steps of residence.

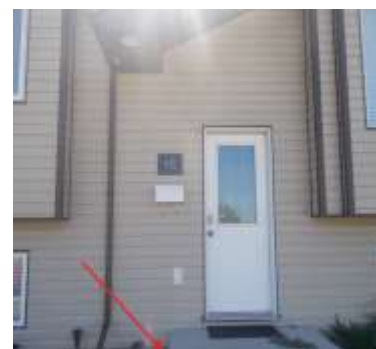
2a - 26AUG14

**Observations:** Cleanout Cap Defective. Next to concrete steps of residence.

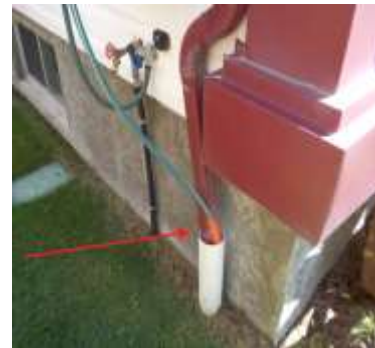
3 - 26AUG14

**Observations:** Downspout from eaves connected to sanitary service.

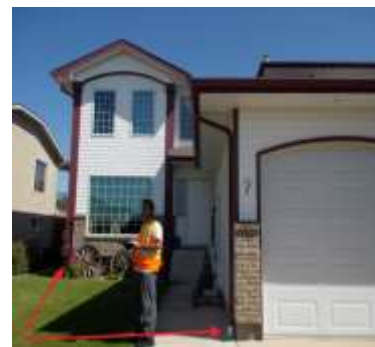
3a - 26AUG14

**Observations:** Downspout from eaves connected to sanitary service.

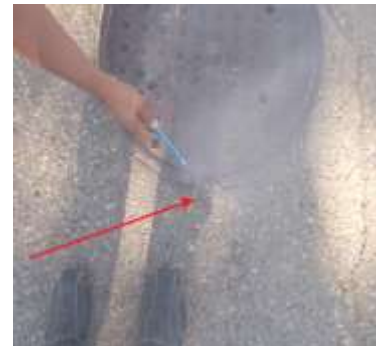
4 - 27AUG14

**Observations:** Smoke from cracked collar Manhole #D978.

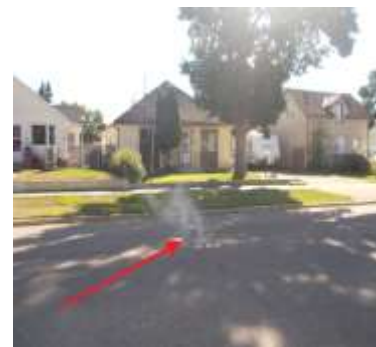
4a - 27AUG14

**Observations:** Smoke from cracked collar Manhole #D978.

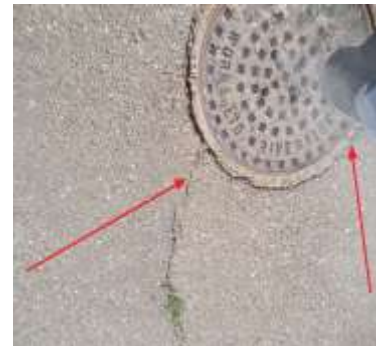
5 - 27AUG14

**Observations:** Smoke from asphalt around collar of Manhole #D979

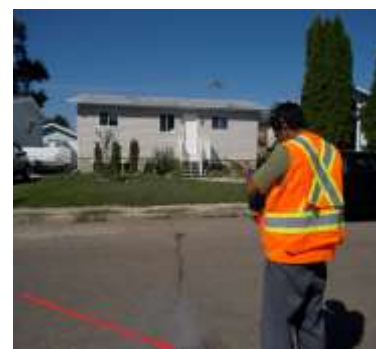
5a - 27AUG14

**Observations:** Smoke from asphalt around collar of Manhole #D979

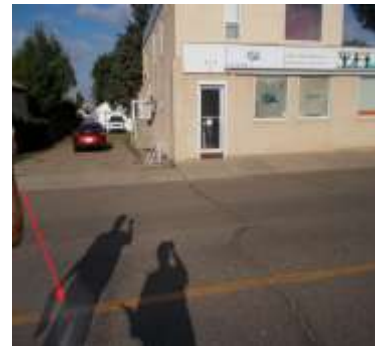
6a - 28AUG14

**Observations:** Smoke from asphalt around collar of Manhole #D92F

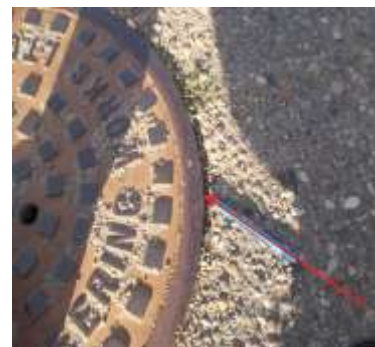
6 - 28AUG14

**Observations:** Smoke from asphalt around collar of Manhole #D92F

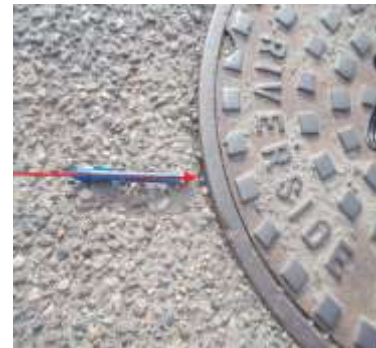
7 - 28AUG14

**Observations:** Smoke from asphalt around collar of Manhole #D930

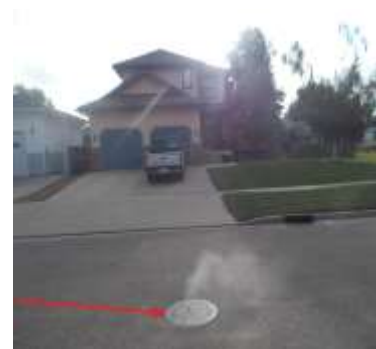
7a - 28AUG14

**Observations:** Smoke from asphalt around collar of Manhole #D930

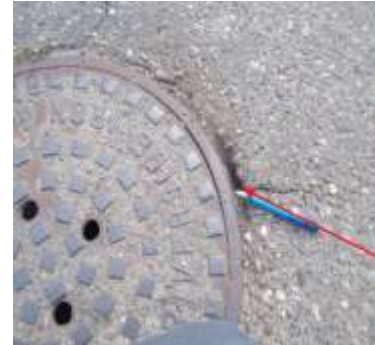
8 - 28AUG14

**Observations:** Smoke from asphalt around collar of Manhole #15611

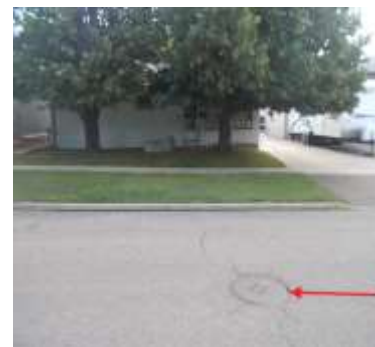
8a - 28AUG14

**Observations:** Smoke from asphalt around collar of Manhole #15611

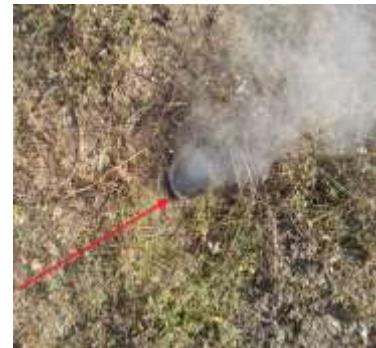
9 - 28AUG14

**Observations:** Abandoned service. Inflow from yard.

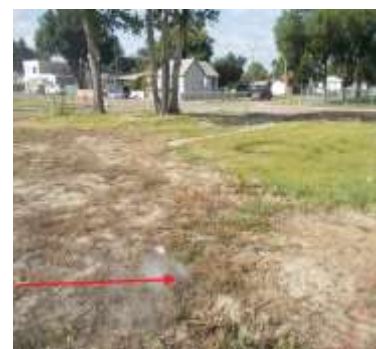
9a - 28AUG14

**Observations:** Abandoned service. Inflow from yard.

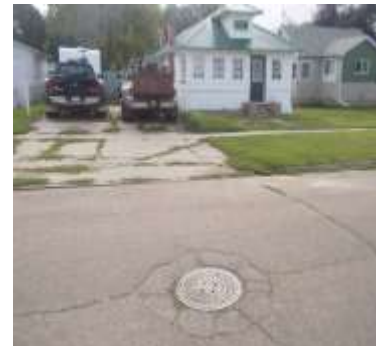
10a - 28AUG14

**Observations:** Smoke from asphalt around collar of Manhole #D976

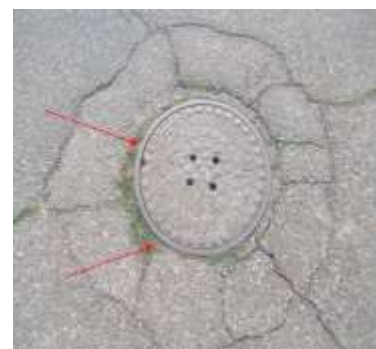
10 - 28AUG14

**Observations:** Smoke from asphalt around collar of Manhole #D976

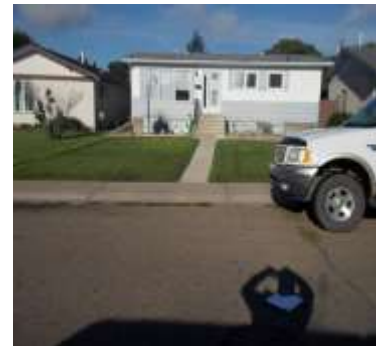
11a - 29AUG14

**Observations:** Smoke from asphalt around collar of Manhole #D981

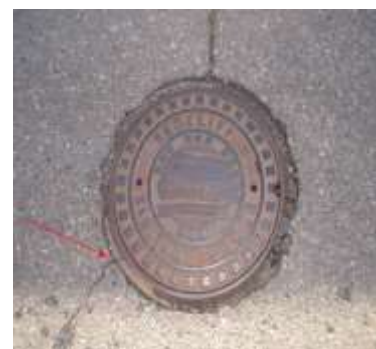
11 - 29AUG14

**Observations:** Smoke from asphalt around collar of Manhole #D981

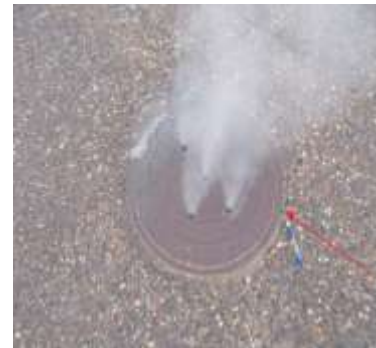
12 - 10SEP14

**Observations:** Smoke from asphalt around collar of Manhole #D8CC

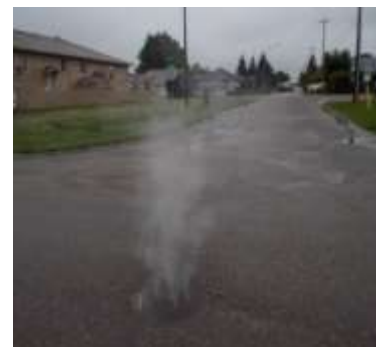
12a - 10SEP14

**Observations:** Smoke from asphalt around collar of Manhole #D8CC

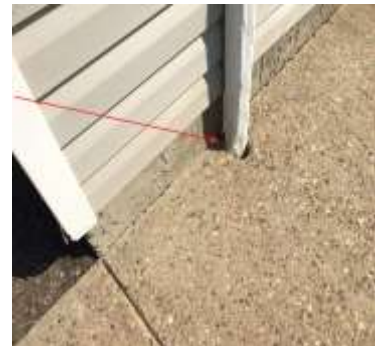
13 - 19AUG14

**Observations:** Downspout from eaves connected to sanitary service.

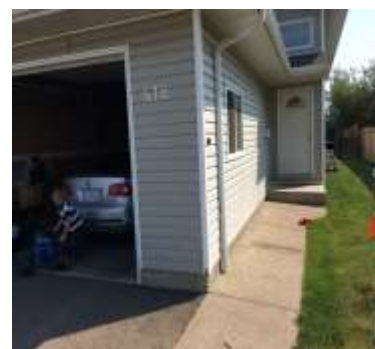
13a - 19AUG14

**Observations:** Downspout from eaves connected to sanitary service.

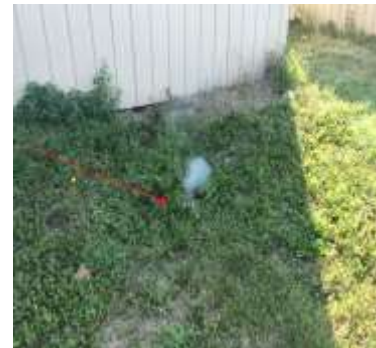
14 - 19AUG14

**Observations:** Cleanout Cap Defective

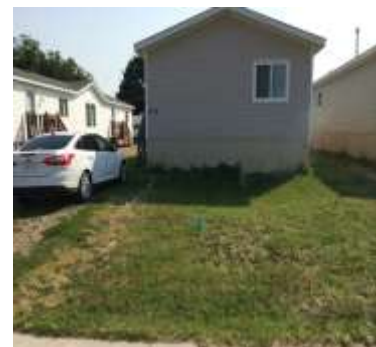
14a - 19AUG14

**Observations:** Cleanout Cap Defective

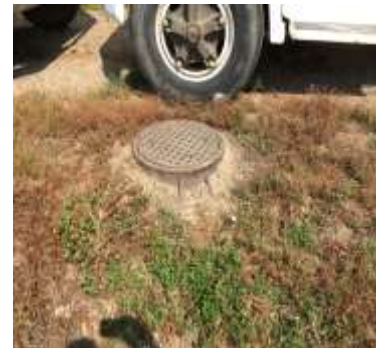
15a - 19AUG14

**Observations:** Smoke from offset MH Collar at MH #D9D4

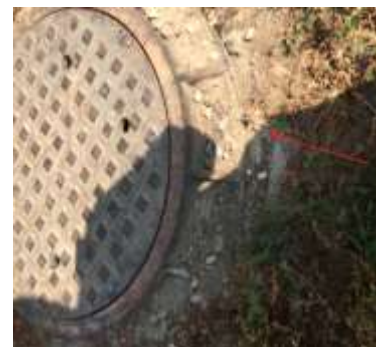
15 - 19AUG14

**Observations:** Smoke from offset MH Collar at MH #D9D4

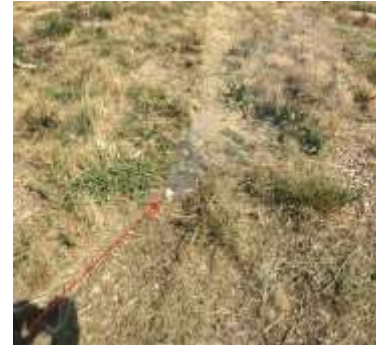
16 - 19AUG14

**Observations:** Smoke from abandoned service. Inflow from yard.

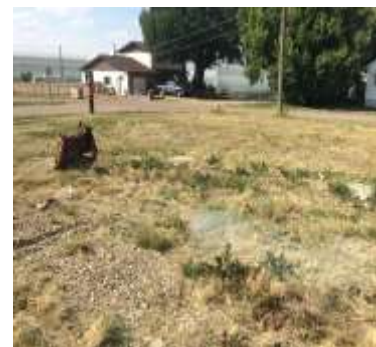
16a - 19AUG14

**Observations:** Smoke from abandoned service. Inflow from yard.

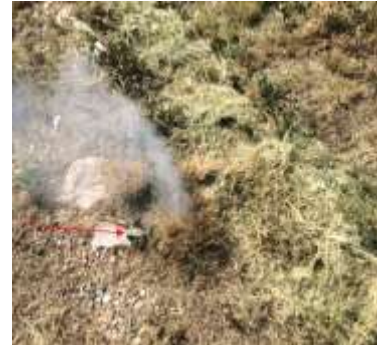
17 - 19AUG14

**Observations:** Smoke from abandoned service. Inflow from yard.

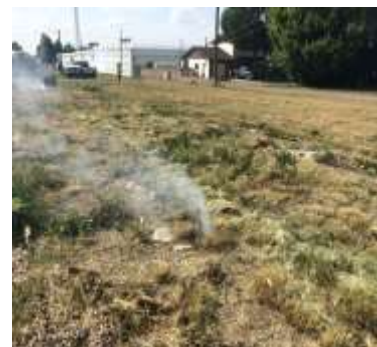
17a - 19AUG14

**Observations:** Smoke from abandoned service. Inflow from yard.

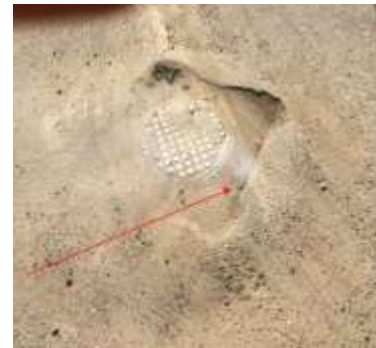
18 - 19AUG14

**Observations:** Smoke from asphalt around MH #D9B8. Inflow from street.

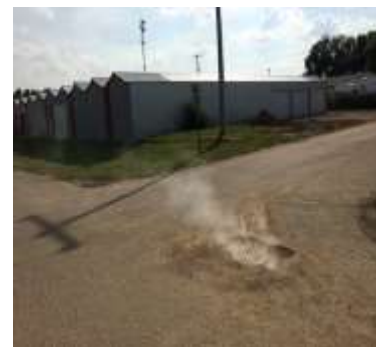
18a - 19AUG14

**Observations:** Smoke from asphalt around MH #D9B8. Inflow from street.

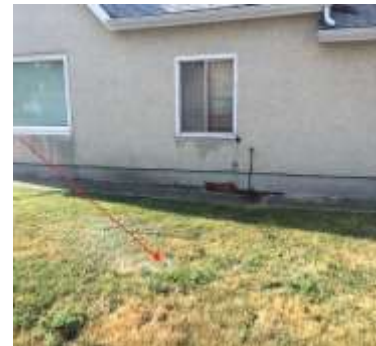
19 - 20AUG14

**Observations:** Smoke from ground. Potential broken service lateral.

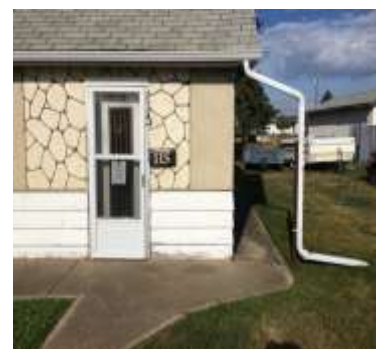
19a - 20AUG14

**Observations:** Smoke from ground. Potential broken service lateral.

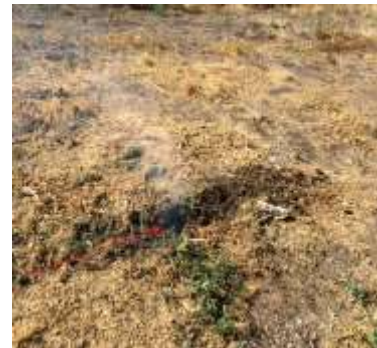
20 - 20AUG14

**Observations:** Smoke from abandoned service. Yard inflow.

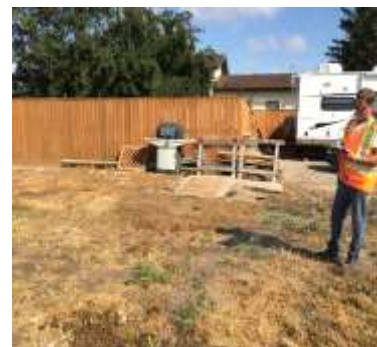
20a - 20AUG14

**Observations:** Smoke from abandoned service. Yard inflow.

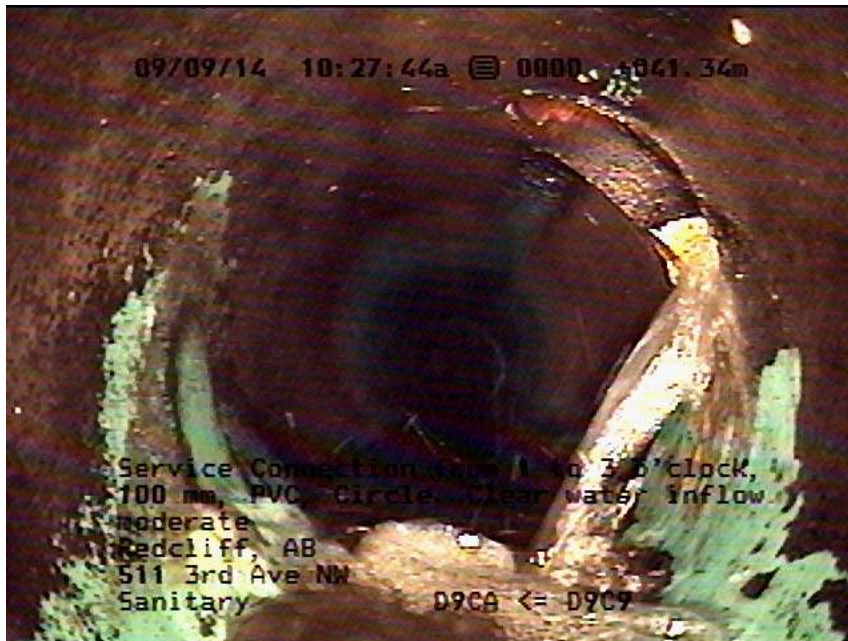
Photo : 1

Service Connection from  
1 to 3 o'clock, 100 mm,  
PVC, Circle. Clear water  
inflow moderate

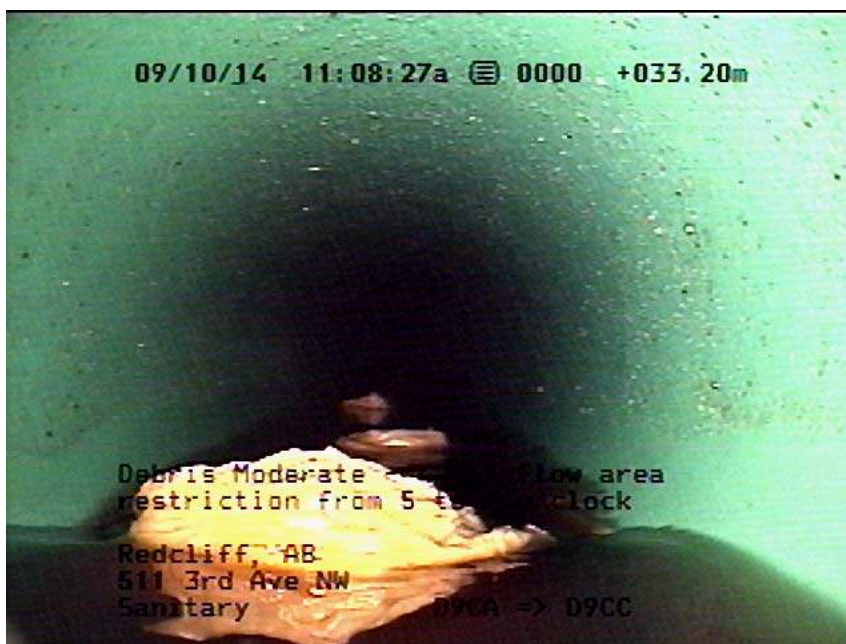
Photo : 3

-3.11	-3.11	II	Moderate volume of dark water discharge from upstream.	00:00:00	2
	0.75	0.75	ST	Start of Survey , 200 mm, PVC, Circle	00:00:00	
	0.75	0.75	II	WL-5%	00:00:00	
	16.27	16.27	BL	Debris Light - Sewer flow not affected	00:00:00	
	33.20	33.20	BM	Debris Moderate - < 25% flow area restriction from 5 to 7 o'clock	00:00:00	3
	33.20	33.20	FH	End of Survey . Unable to pass debris.	00:00:00

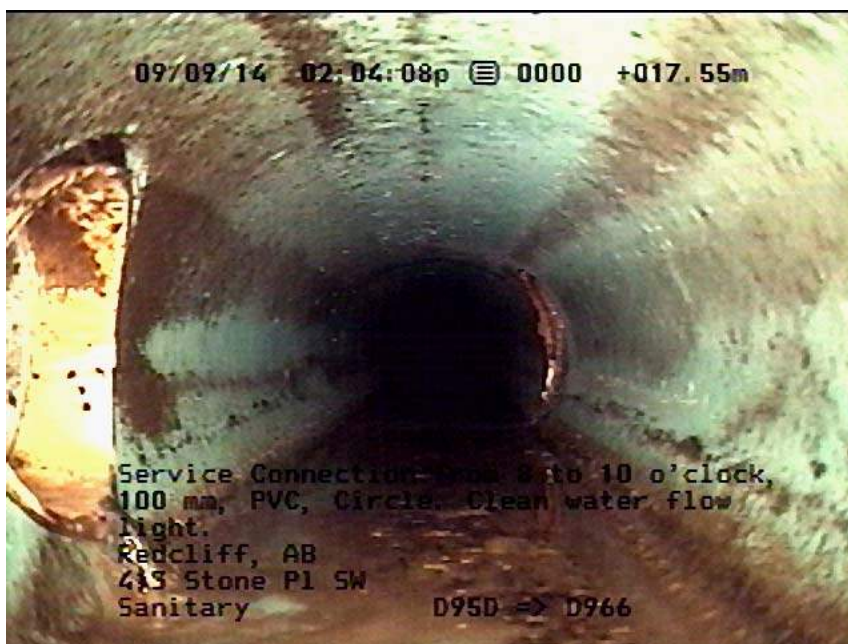
**Photo** : 2  
**Distance** : 17.55 m  
**Video** : 00:00:00  
**DC** :  
**Code** : CN  
Service Connection from  
8 to 10 o'clock, 100 mm,  
PVC, Circle. Clean water  
flow light.

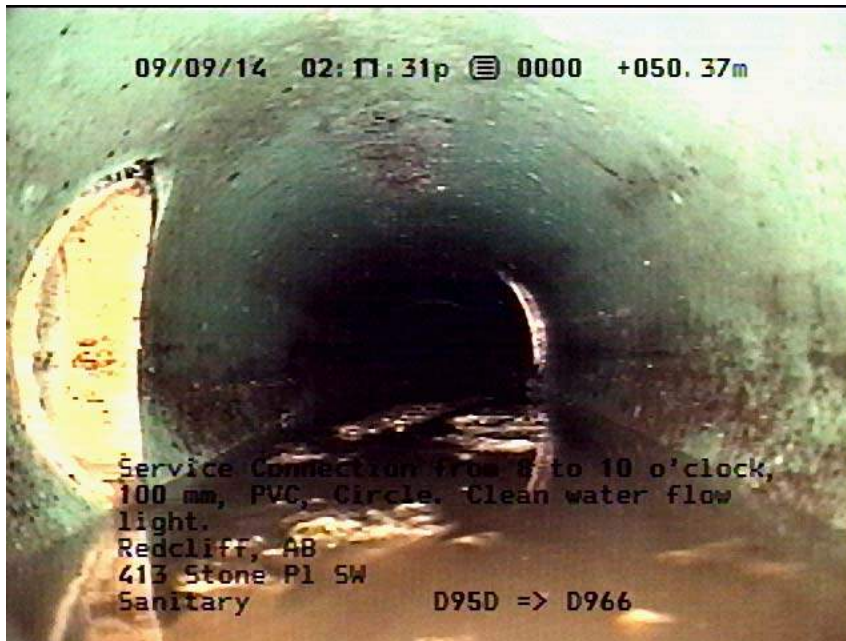
Photo : 3

Service Connection from  
8 to 10 o'clock, 100 mm,  
PVC, Circle. Clean water  
flow light.

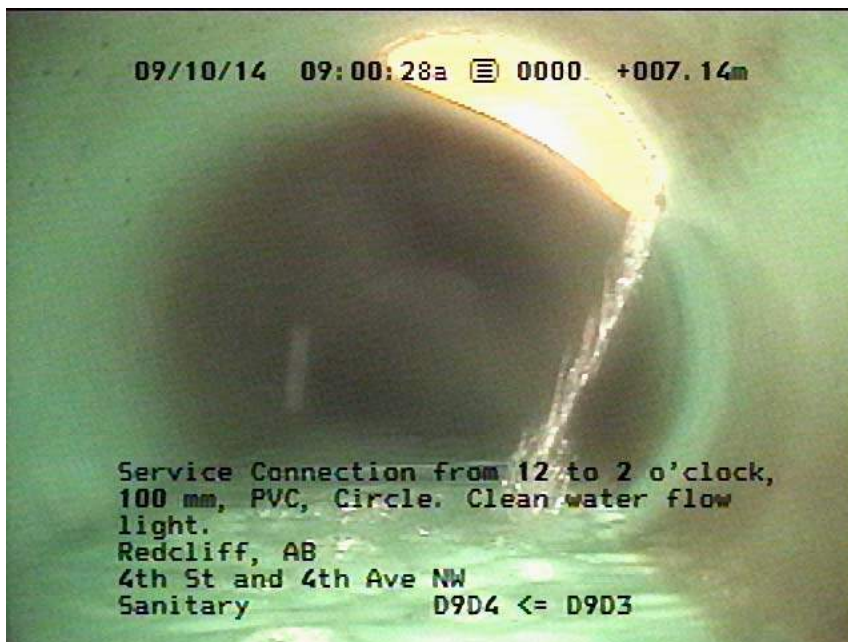
Photo : 1  
Distance : 11.60 m  
Video : 00:00:00  
DC :  
Code : CN  
Service Connection from 12 to 2 o'clock, 100 mm, PVC, Circle. Clean water flow light.

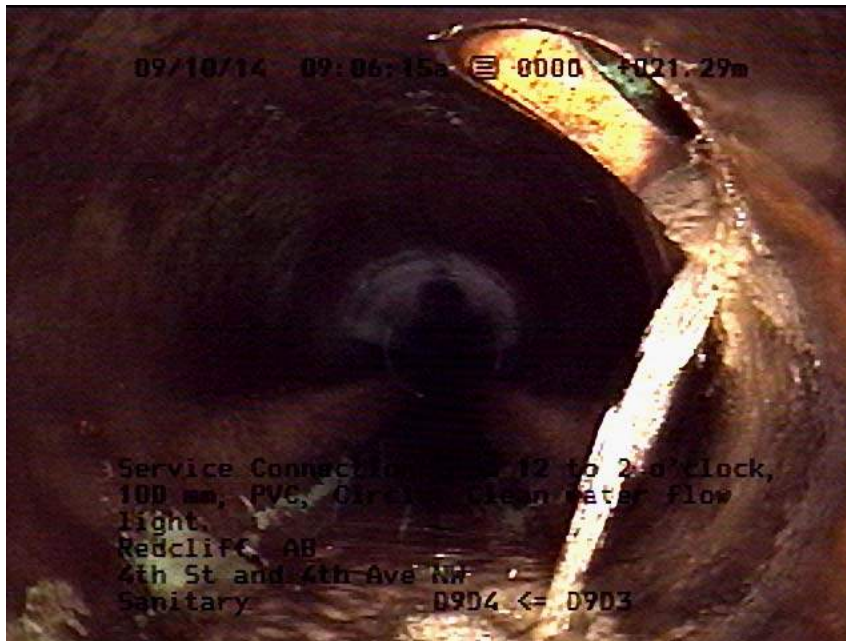
**Photo** : 2

Service Connection from  
12 to 2 o'clock, 100 mm,  
PVC, Circle. Clean water  
flow light.

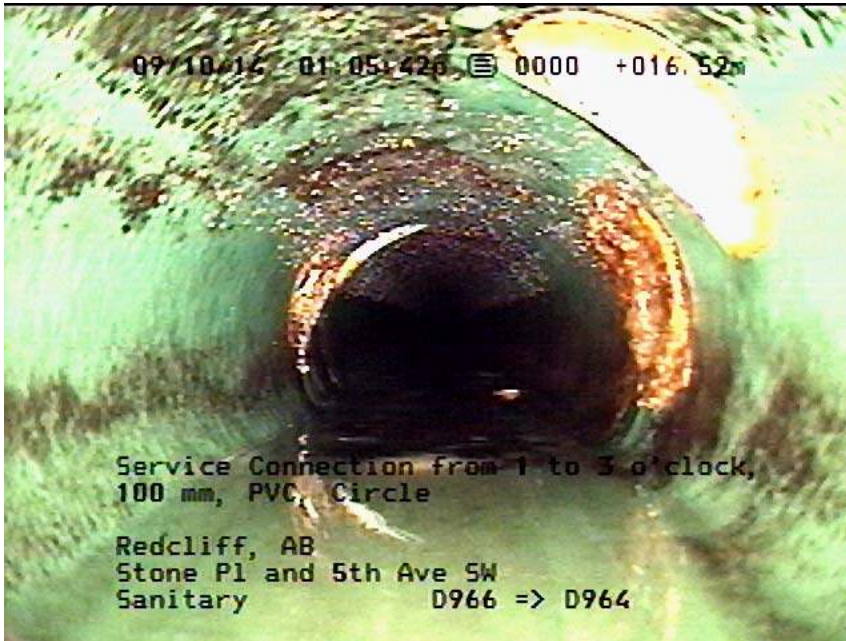
**Photo** : 1  
**Distance** : 16.52 m  
**Video** : 00:00:00  
**DC** :  
**Code** : CN  
Service Connection from  
1 to 3 o'clock, 100 mm,  
PVC, Circle

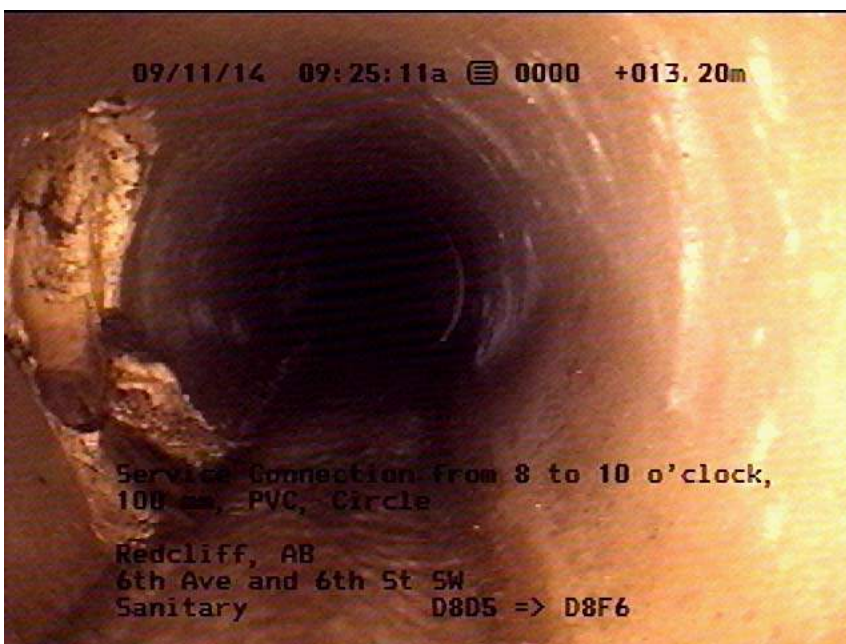
Photo : 2  
Distance : 13.20 m  
Video : 00:00:00  
DC :  
Code : CN  
Service Connection from  
8 to 10 o'clock, 100 mm,  
PVC, Circle

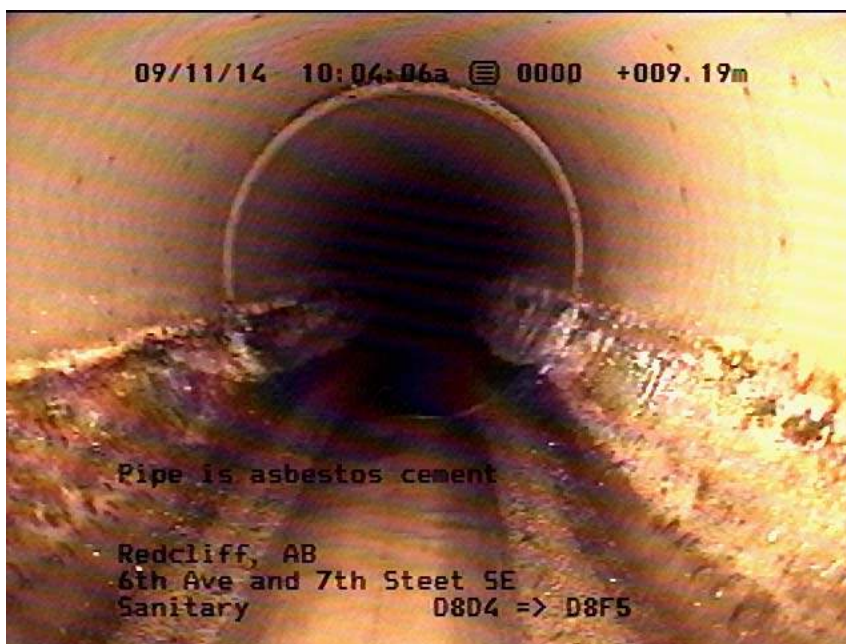
Photo : 2  
Distance : 9.19 m  
Video : 00:00:00  
DC :  
Code : II  
Pipe is asbestos cement

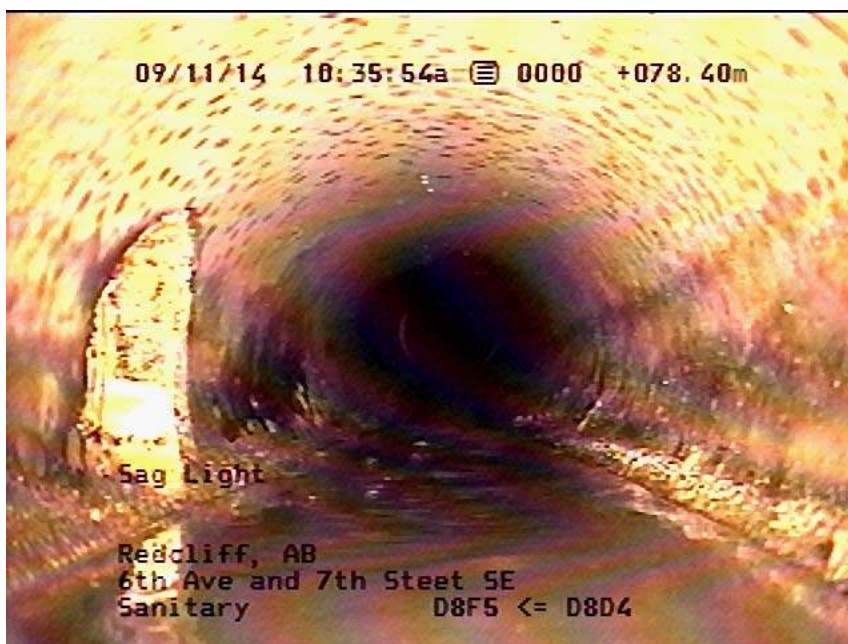
**Photo** : 2  
**Distance** : 78.40 m  
**Video** : 00:00:00  
**DC** :  
**Code** : SL  
Sag Light

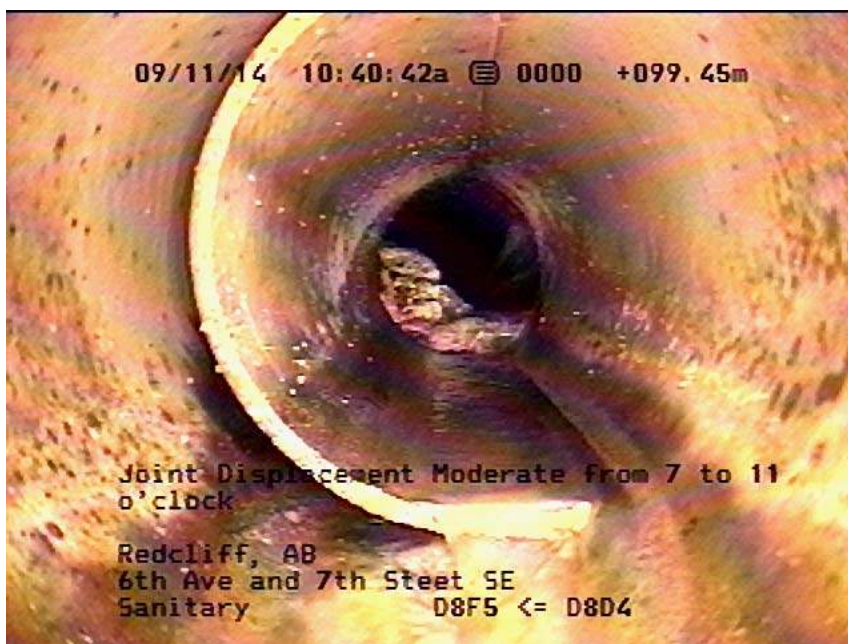
**Photo** : 4  
**Distance** : 99.45 m  
**Video** : 00:00:00  
**DC** :  
**Code** : JM  
Joint Displacement  
Moderate from 7 to 11  
o'clock

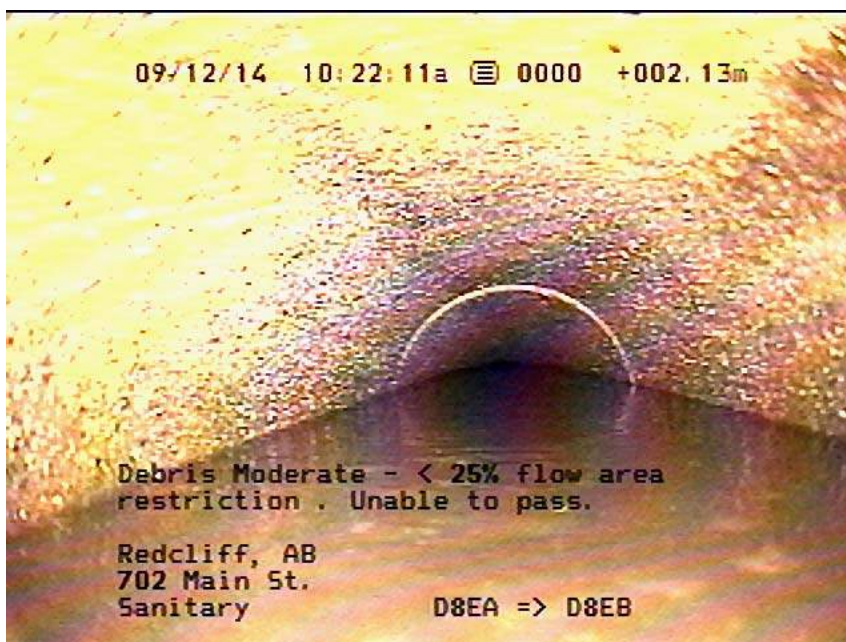
**Photo** : 2  
**Distance** : 2.13 m  
**Video** : 00:00:00  
**DC** :  
**Code** : BM  
Debris Moderate - < 25%  
flow area restriction .  
Unable to pass.

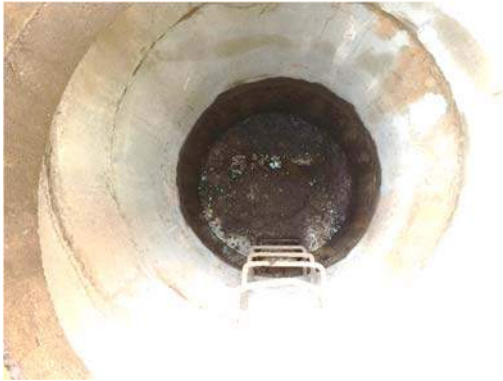
**Manhole: D95B**

Unable to enter with camera. Manhole has a lot of debris.

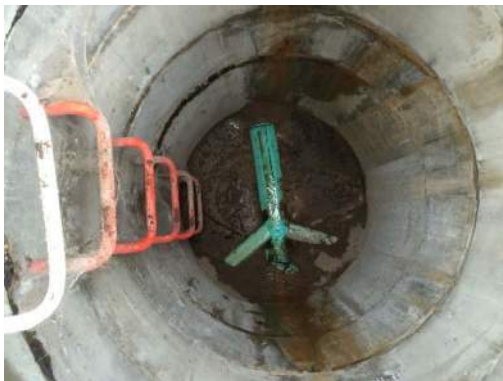
**Manhole: D95D**

Manhole OK. Many pipes entering manhole.

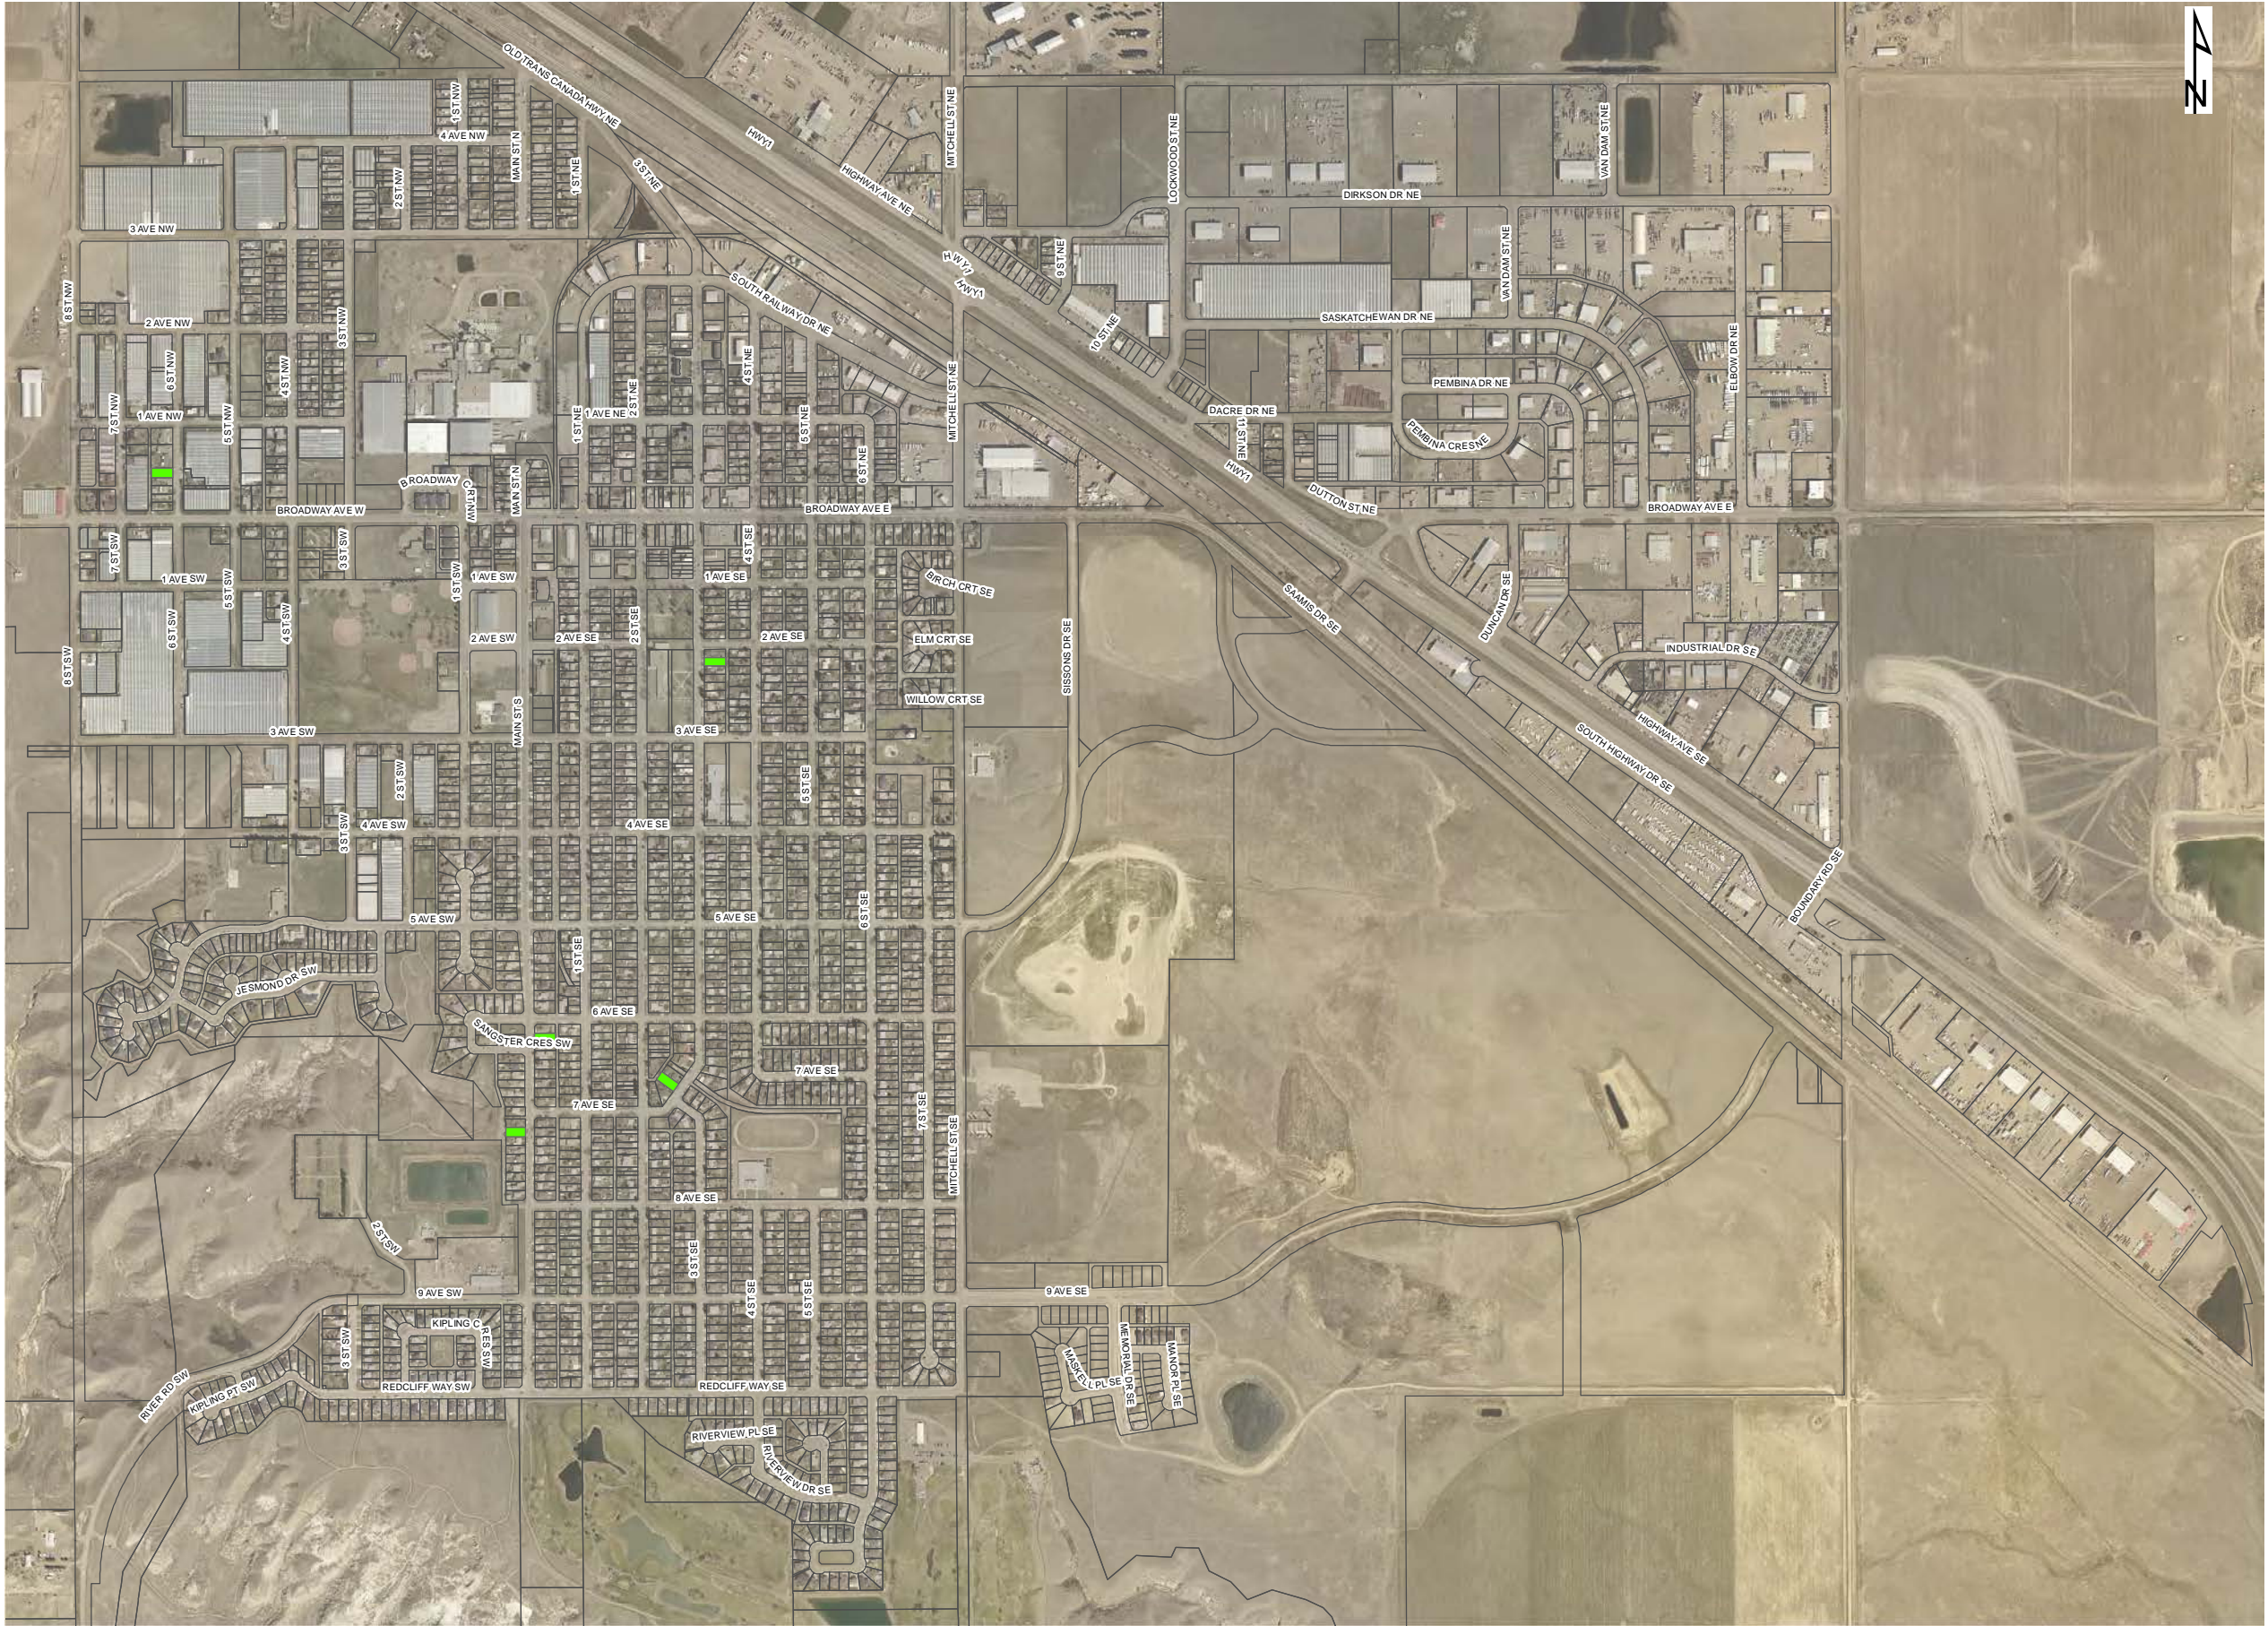
FIGURE 6.6

- Figure 6.5 shows residents reporting basement drains to sanitary or an unknown location
  - Generally, data is clustered in the south. This is less of an issue than weeping tiles or sump pumps which can discharge groundwater or infiltration, but is taken to note.

SURVEY RESULTS  
BASEMENT DRAIN  
LOCATION BY LOT
